# **PLANT WATSON**

## **MISSISSIPPI POWER**

STEAM TURBINE CONTROL  
FLUID MAINTENANCE  
BEST PRACTISES

**Lubrication Excellence 2003**

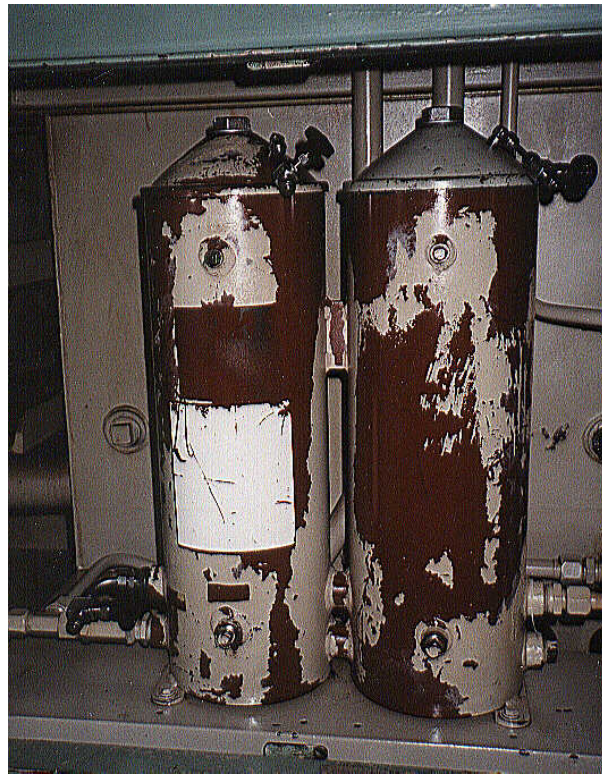
First, the fuller's earth housings (see Photo 1) only take one Hilliard HT718-00-CN fuller's earth cartridge. Consequently, there are only two in total. At a Hilliard recommended flowrate of  $\frac{1}{2}$  gpm per cartridge this is only 1 gpm. However, the operating manual says 2.4 gpm and is incorrect in not allowing enough contact time with the media. Plus, there is no flow gauge on the system and the dial on the Vickers flow control valve, see Photo 2, is not that easy to read but worse it is left handed so that when efforts were made to reduce the flow, it was being increased. Lastly, some of the pressure gauges were not functioning or had been removed. These had to be replaced with the right ones; note only phosphate ester compatible pressure gauges should be used. As a check, the pressure with new fuller's earth and new filter elements should be as follows;

Photo 1: Showing typical fuller's earth housings. Flow is in parallel with one cartridge in each housing.

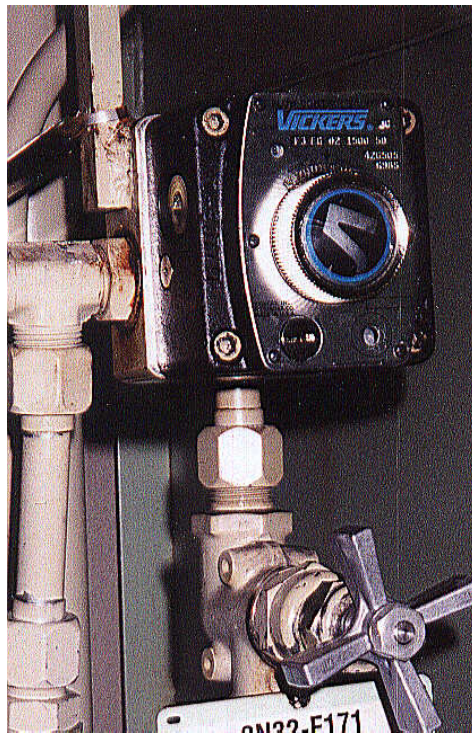
Photo 2: Showing a flow control valve.

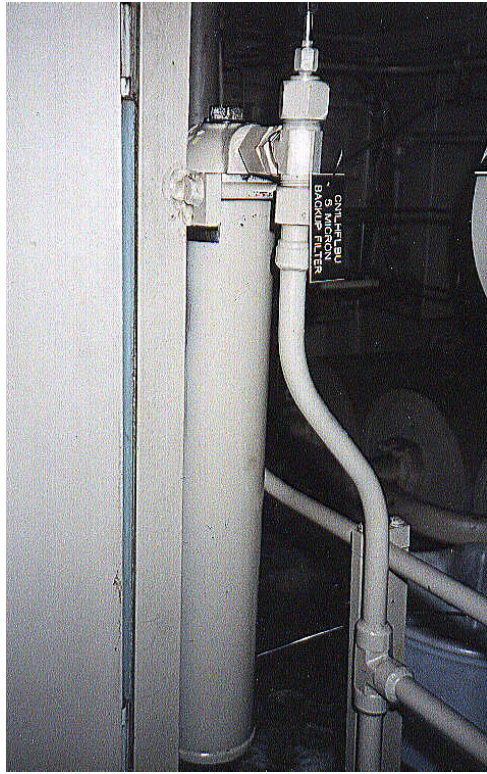
Photo 3: Showing a PL310 trap filter housing.

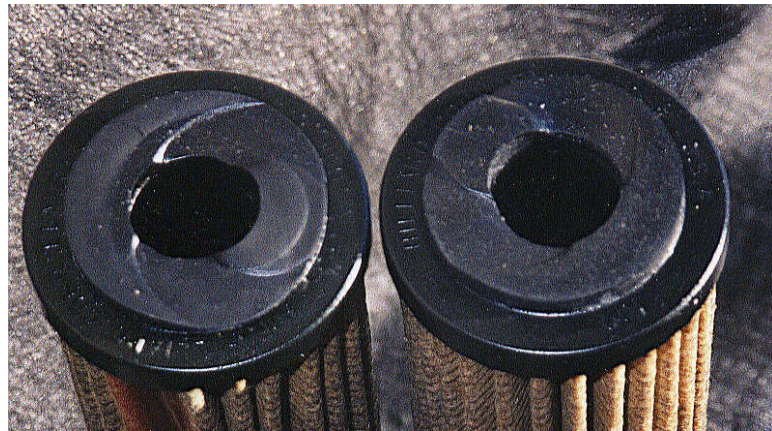
Lastly, used 10" trap filter elements were examined and this showed that the elements were being misaligned. See Photo 4. As a result fuller's earth fines could bypass the trap filter and go right into the main reservoir. To prevent this from happening the trap filter was upgraded to a 20" filter element provided by Forsythe. This also had a better rating so it was a win win situation.

Photo 4: Showing the short 10" trap filter elements that were misaligned.

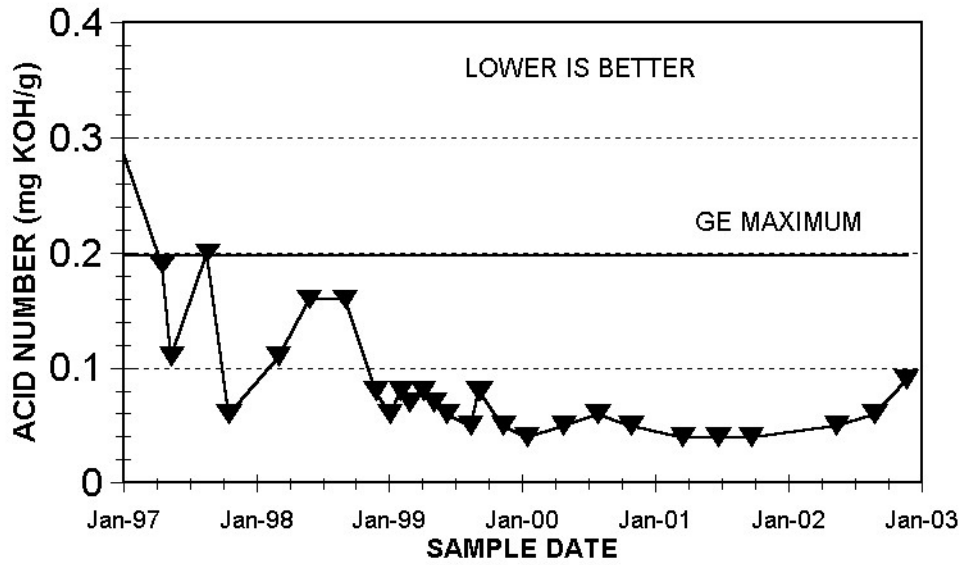
Figure 1: Acid Number.

**Acid Number:** Currently low which is good and averaging about 0.05 mgKOH/g over this year it is well below the GE limit of 0.20 mgKOH/g. This indicates that the purification media is being effective. See Figure 1. While not shown the metal content of the fluid has dropped as well and the magnesium content in particular is down from over 20 to 2 ppm.

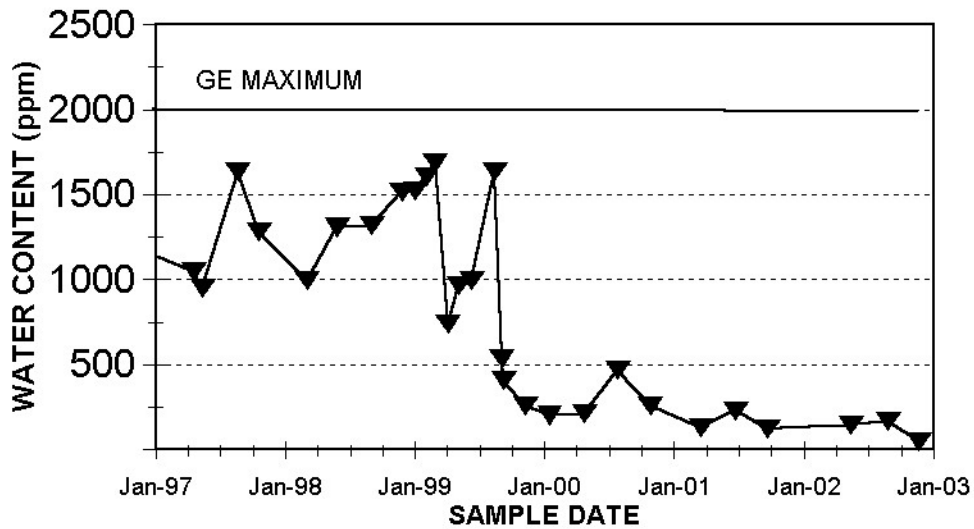
Figure 2: Water Content.

**Water Content:** Currently very low averaging about 200 over the year which is also good. It is well below the GE maximum of 2,000 ppm and most likely reflects the use of purge air on the reservoir. See Figure 2.

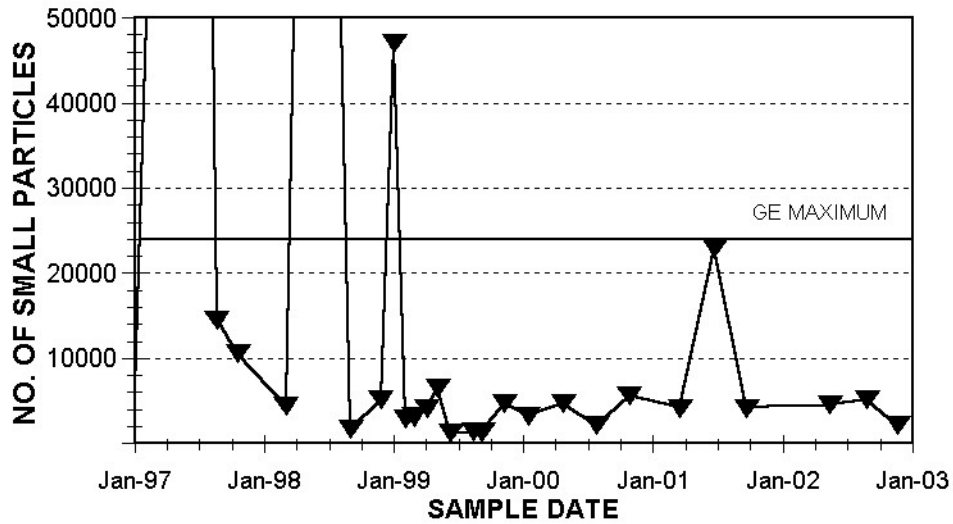
Figure 3: Small Particles (5-10 microns optical count).

**Particle Count:** Much improved with only one spike which would be of concern if associated with any maintenance activity or unusual system operation. Otherwise it could be sampling which should be addressed if it happens again. See Figure 3.

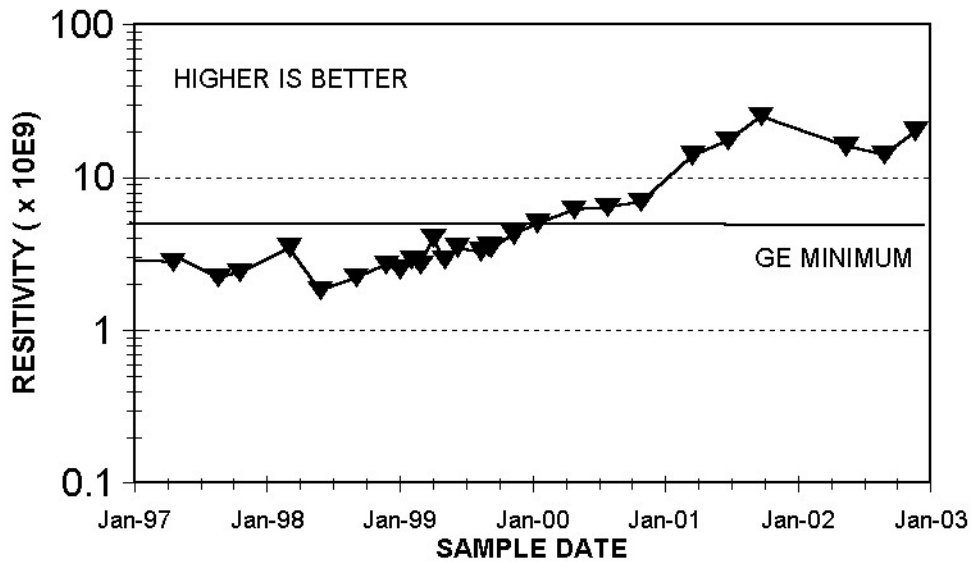
Figure 4: Resistivity

**Resistivity:** Now well above the GE minimum of 5 Gohm.cm, which is good, plus it is still trending higher which is even better. See Figure 4.
