PLANT WATSON

MISSISSIPPI POWER

STEAM TURBINE CONTROL
FLUID MAINTENANCE
BEST PRACTISES

GLCC REOLUBE TURBOFLUID 46B

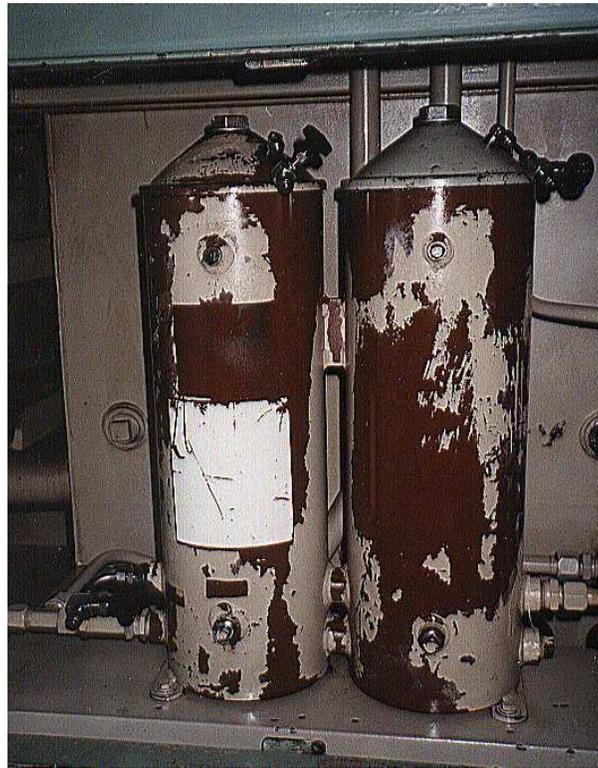
First, the fuller's earth housings (see Photo 1) only take one Hilliard HT718-00-CN fuller's earth cartridge. Consequently, there are only two in total. At a Hilliard recommended flowrate of $\frac{1}{2}$ gpm per cartridge this is only 1 gpm. However, the operating manual says 2.4 gpm and is incorrect in not allowing enough contact time with the media. Plus, there is no flow gauge on the system and the dial on the Vickers flow control valve, see Photo 2, is not that easy to read but worse it is left handed so that when efforts were made to reduce the flow, it was being increased. Lastly, some of the pressure gauges were not functioning or had been removed. These had to be replaced with the right ones; note only phosphate ester compatible pressure gauges should be used. As a check, the pressure with new fuller's earth and new filter elements should be as follows;

Photo 1: Showing typical fuller's earth housings. Flow is in parallel with one cartridge in each housing.

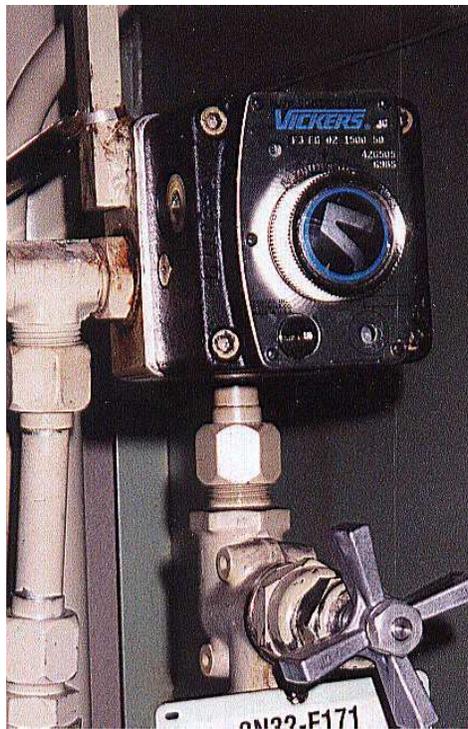
Photo 2: Showing a flow control valve.

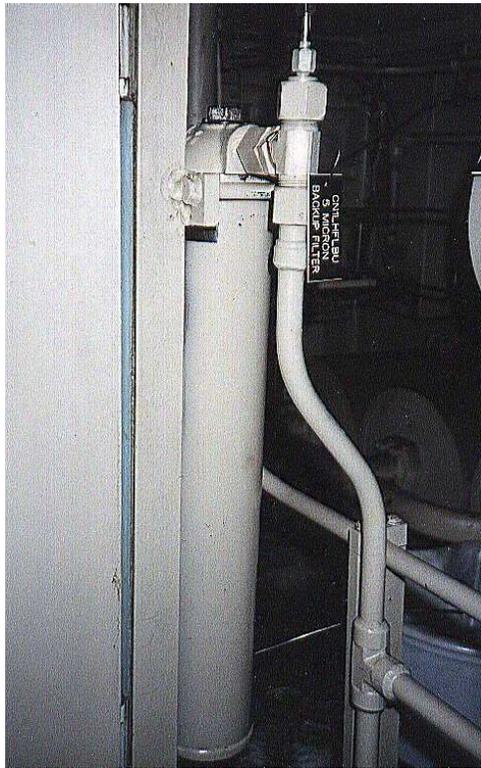
Photo 3: Showing a PL310 trap filter housing.

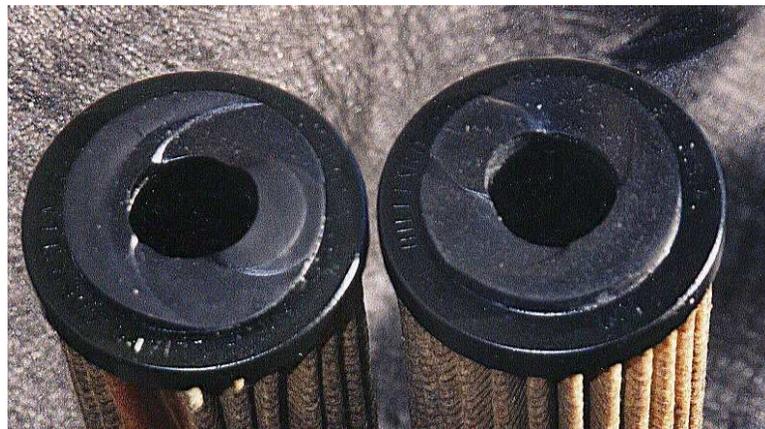
Lastly, used 10" trap filter elements were examined and this showed that the elements were being misaligned. See Photo 4. As a result fuller's earth fines could bypass the trap filter and go right into the main reservoir. To prevent this happening the trap filter was upgraded to a 20" filter element provided by Forsythe. This also had a better rating so it was a win win situation.

Photo 4: Showing the short 10" trap filter elements that were misaligned.

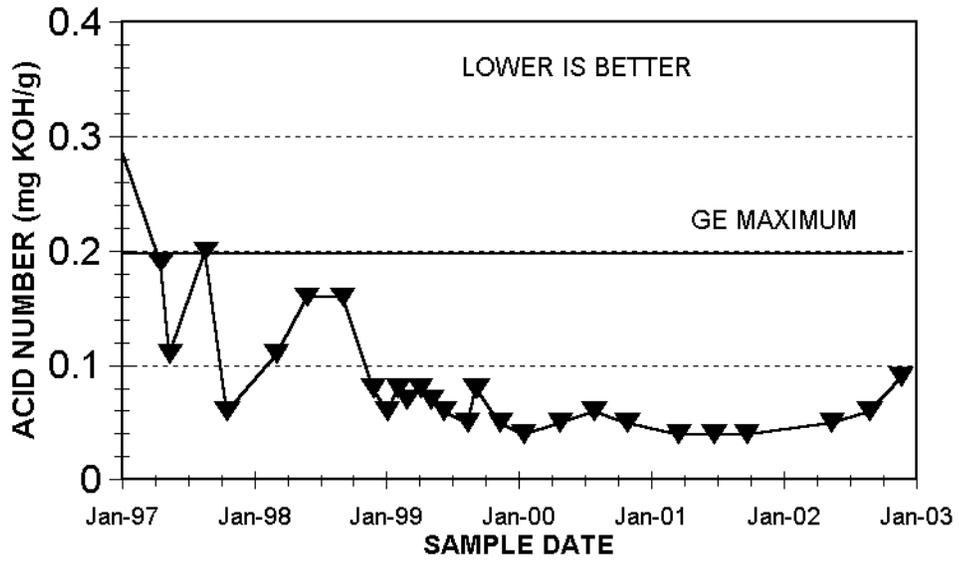
Figure 1: Acid Number.

Acid Number: Currently low which is good and averaging about 0.05 mgKOH/g over this year it is well below the GE limit of 0.20 mgKOH/g. This indicates that the purification media is being effective. See Figure 1. While not shown the metal content of the fluid has dropped as well and the magnesium content in particular is down from over 20 to 2 ppm.

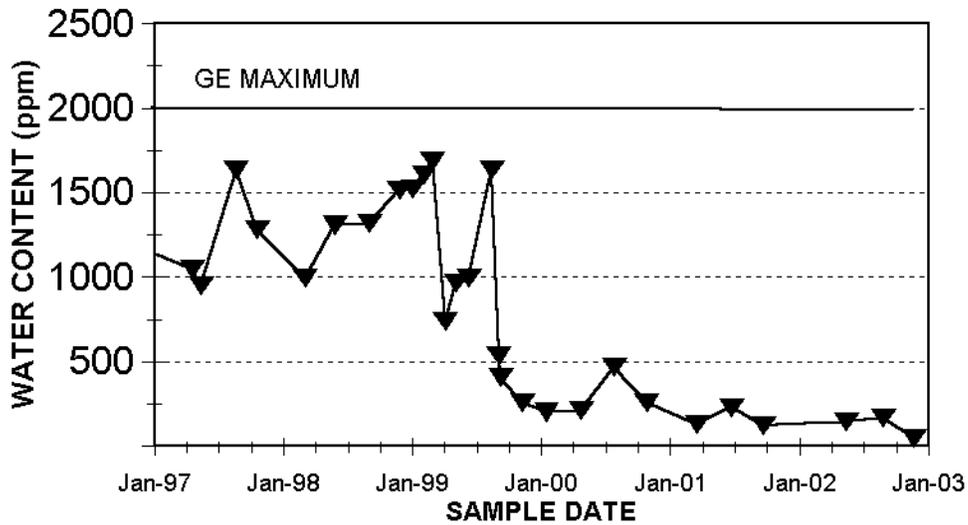
Figure 2: Water Content.

Water Content: Currently very low averaging about 200 over the year which is also good. It is well below the GE maximum of 2,000 ppm and most likely reflects the use of purge air on the reservoir. See Figure 2.

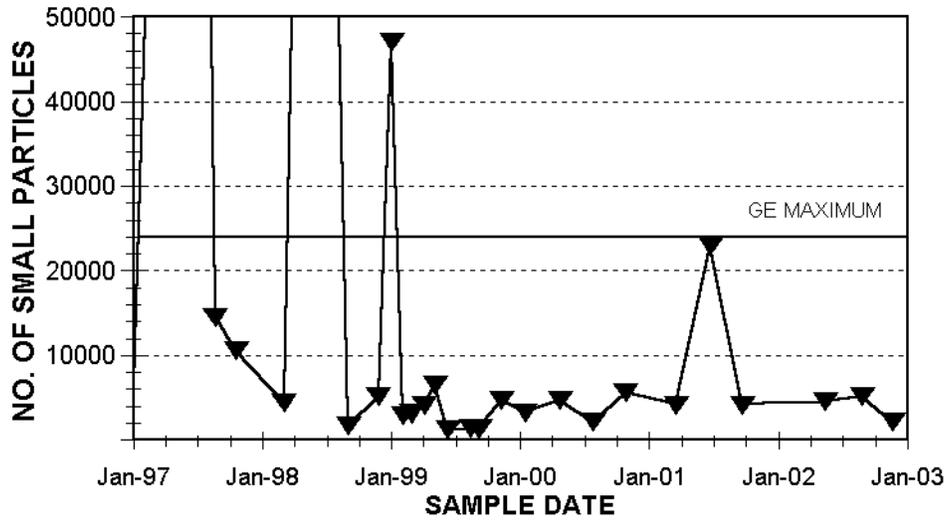
Figure 3: Small Particles (5-10 microns optical count).

Particle Count: Much improved with only one spike which would be of concern if associated with any maintenance activity or unusual system operation. Otherwise it could be sampling which should be addressed if it happens again. See Figure 3.

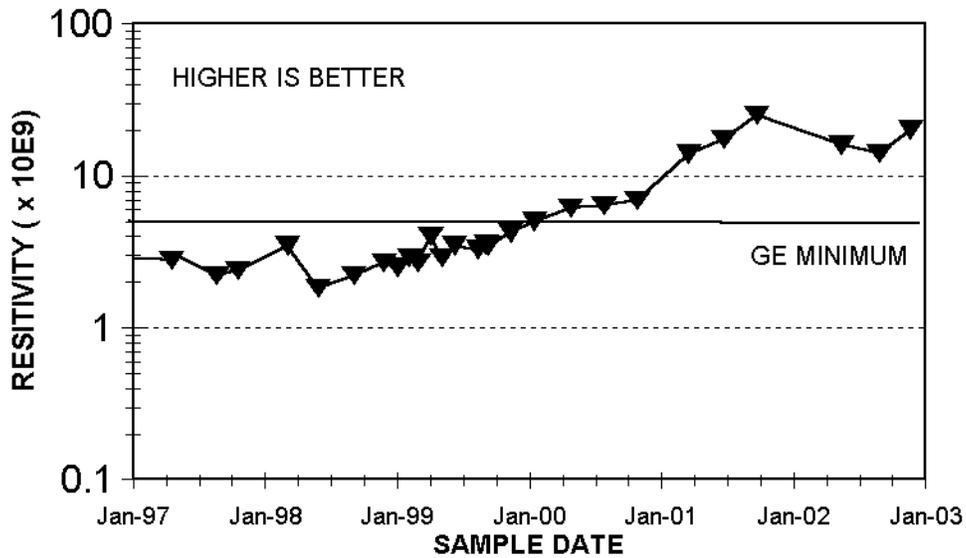
Figure 4: Resistivity.

Resistivity: Now well above the GE minimum of 5 Gohm.cm, which is good, plus it is still trending higher which is even better. See Figure 4.
